DEPARTMENT OF NATURAL RESOURCES  
DIVISION OF OIL, GAS AND MINING

RE: Site Inspection, Absolute Mining and Minerals, Inc., AMMI Project, S/019/035, Grand County, Utah

Date of Inspection: June 11, 2002  
Time of Inspection: 10:00 until 11:10 a.m.  
Conditions: Clear, 70's  
Participants: Paul Baker, DOGM

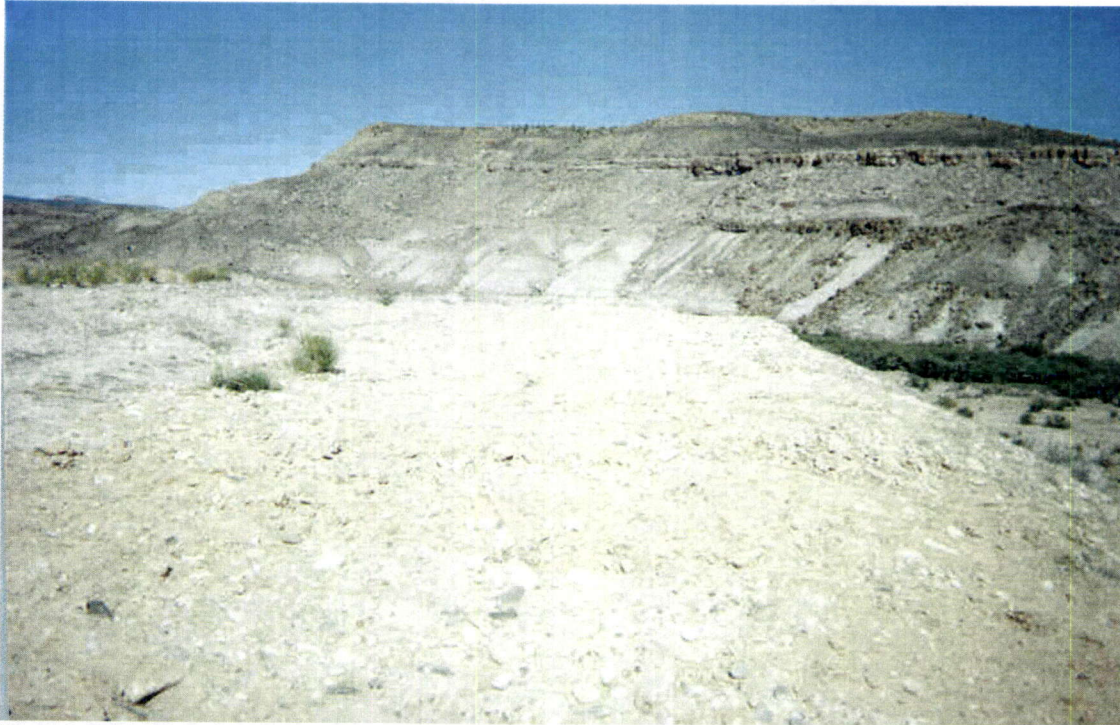
I could see evidence of last fall's reclamation on top of the hill. It appears that some soil was brought to the top of the hill and graded around the sides (Photo 1). This material is a different color

than the material existing on the hill, and it looks like it might make a better growth medium. Before the rest of the hill is covered with soil, some areas will need to be graded (Photo 2).

Photo 1. Right side shows new soil on top of the knoll. Note the reddish color of the right side compared to the left.

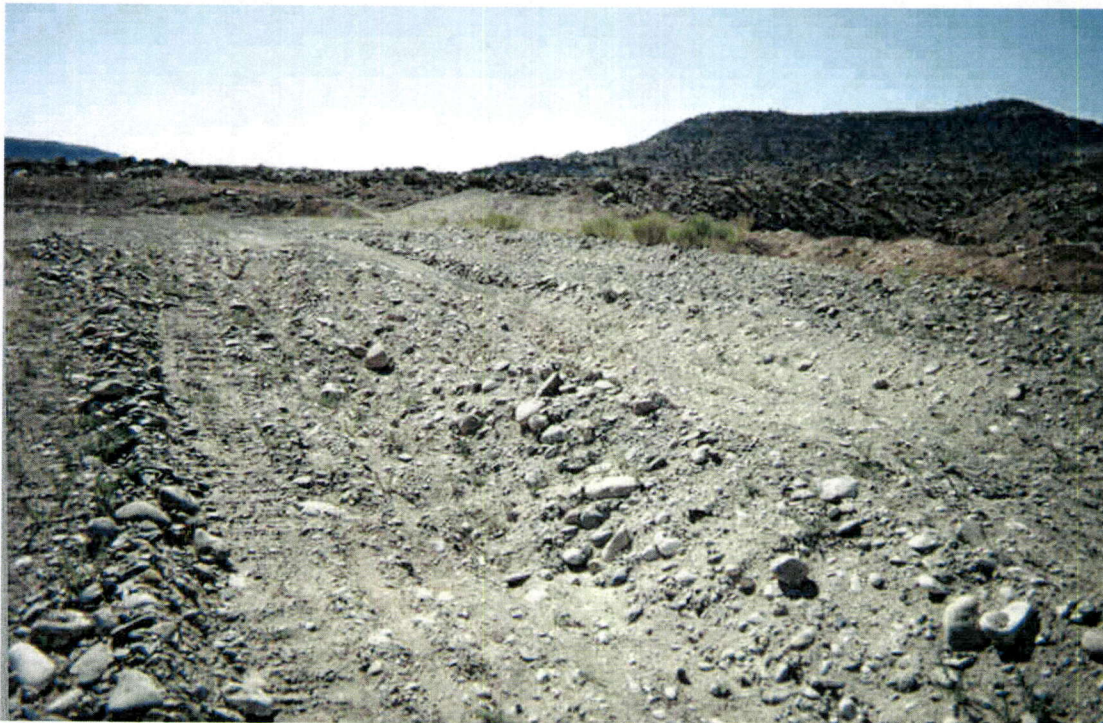
Photo 2. Unreclaimed portion of the top of the knoll.

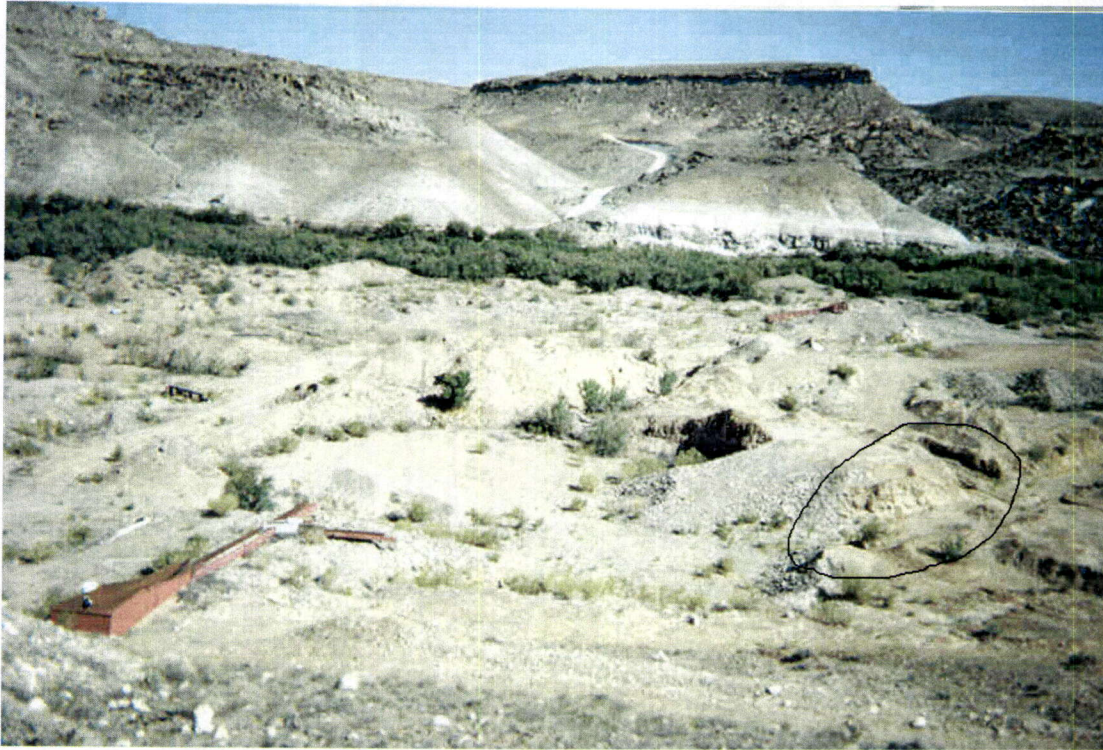
I looked for the place from which the soil came, and it appears to have been borrowed from some of the processed material just north of the disturbed area boundary (Photo 3). There were fairly fresh tracks leading to this area, and it was obvious a few scoops of this material had been removed. The travelway and area from which the material was removed is about 90 feet long and about 12 feet wide for a total area of about 1080 square feet. Although this is not a large area—only 0.02 acres—it brings the total disturbed area up to exactly 5.0 acres from 4.98.

Photo 3. The upper right portion of the circled area is the place from which it appears soil was taken for reclamation of the knoll. A short travelway is also in the marked area.

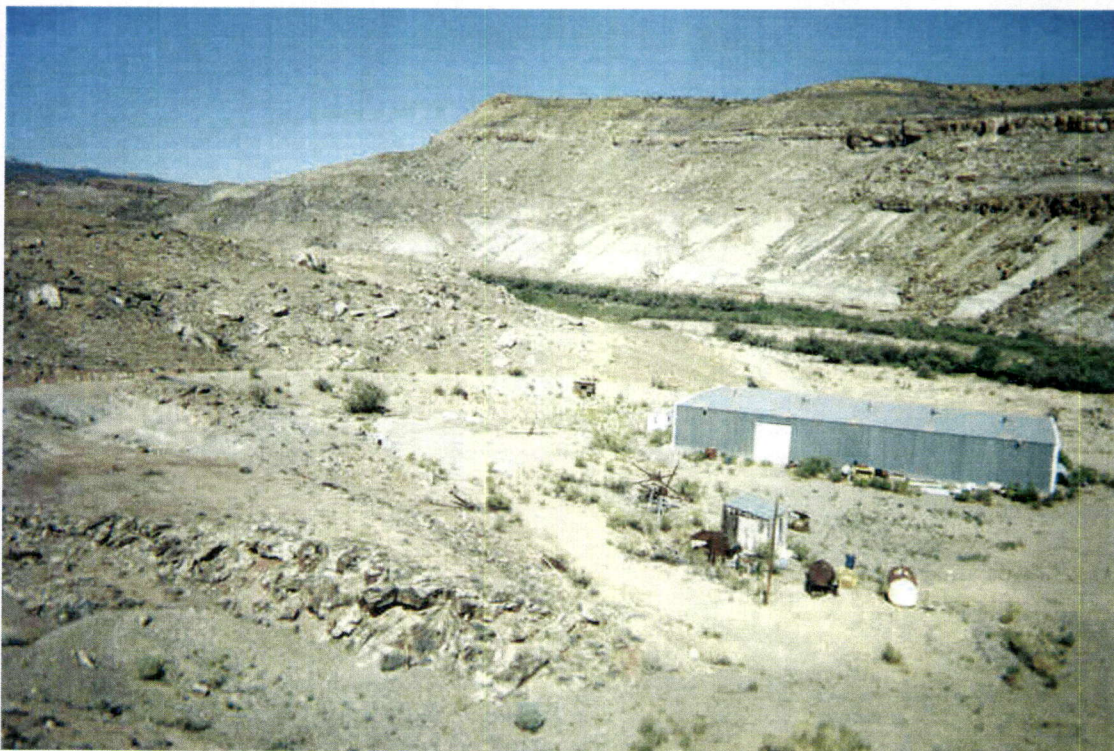
I saw no evidence of any recent reclamation efforts in the pad area (Photo 4).

Photo 4. Pad area. The area that was to have been reclaimed is to the left of the larger building and extends generally toward the viewer.
